**NEWTON PUBLIC BUILDINGS SURVEY
PHASE II – ANALYSIS OF HISTORICAL SIGNIFICANCE**

Angino Community Farm

Address: 303 Nahanton Street
Year of Construction: 1855

Phase II: Analysis of Historically Significant City Buildings, Newton, Massachusetts
Angino Community Farm
DRAFT 4/6/2012

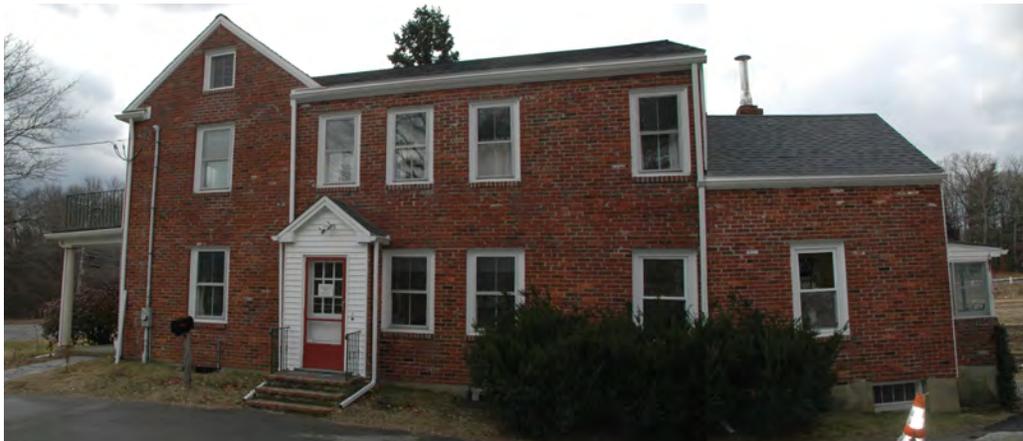
Figure 1 (top): east elevation. The evolution of the house can be seen in the series of additions from the original structure, at the left in this photo.

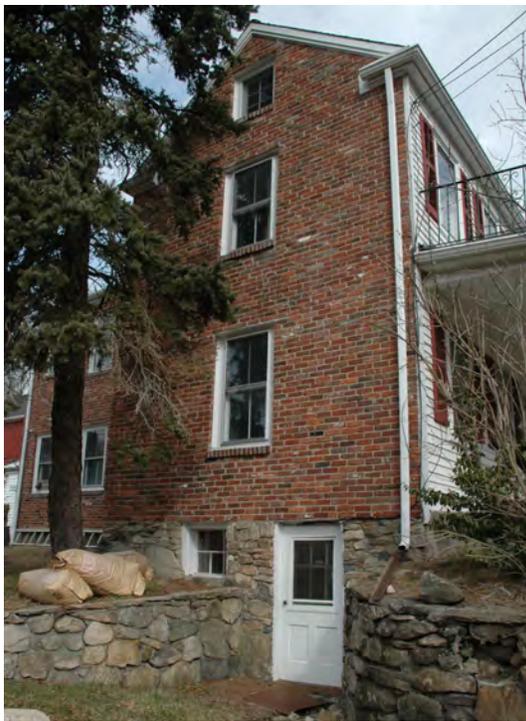
Figure 2 (center left): many materials on the exterior: clapboards on the front, stone rubble foundation, brick for most of the house.

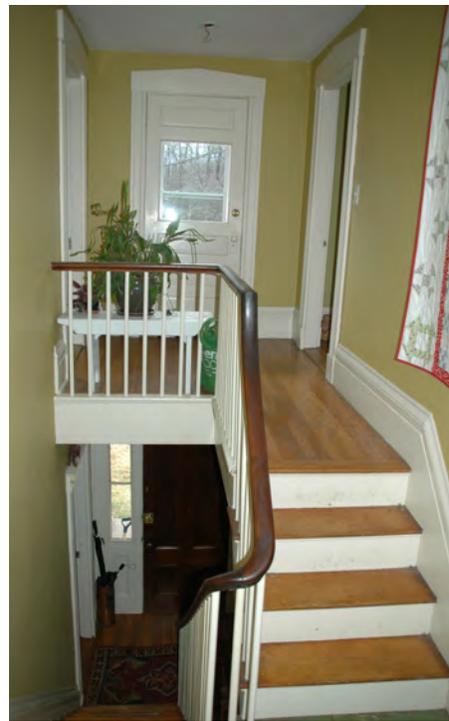
Figure 3 (center right): the front stair well is in good condition. The pointed window and door trim is typical of the front segment of the house; it is slightly more elaborate at the first floor.

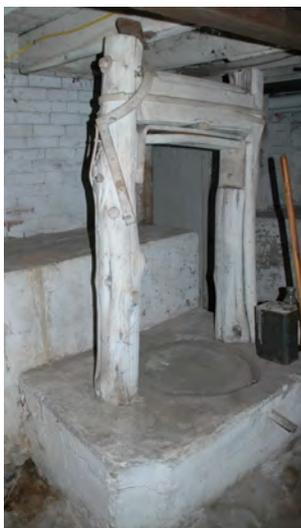
Figure 4 (bottom): the wine press in the basement

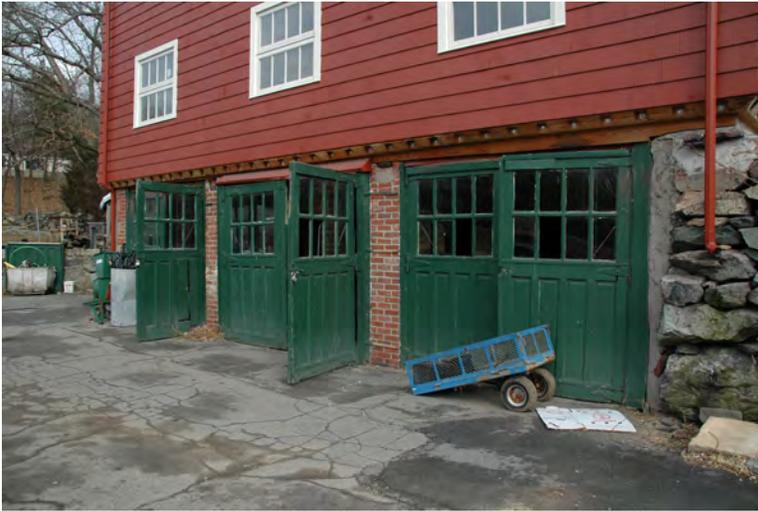
Figure 5 (top left): the three sets of lower level doors sit directly below the recently replaced sill plate. A window is centered above each pair of doors.

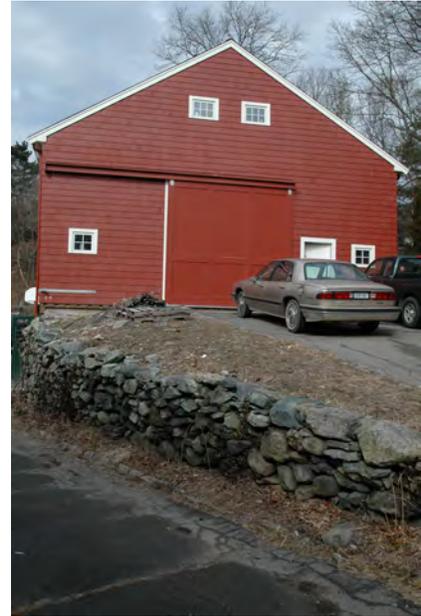
Figure 6 (top right): the front entrance to the main level is accessed by an earthen ramp; to the west, the land slopes downward, to the level of the lower level doors

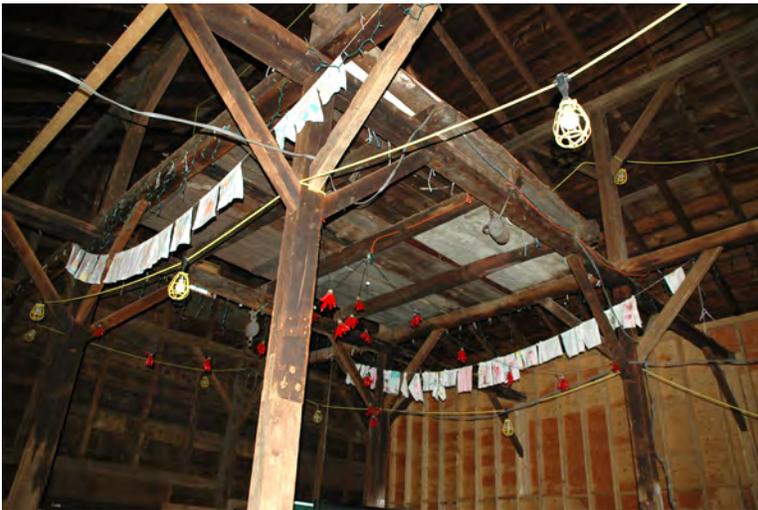
Figure 7 (center left): the supports for the hayloft have solid joinery repairs. Note the recently replaced east exterior wall in the background

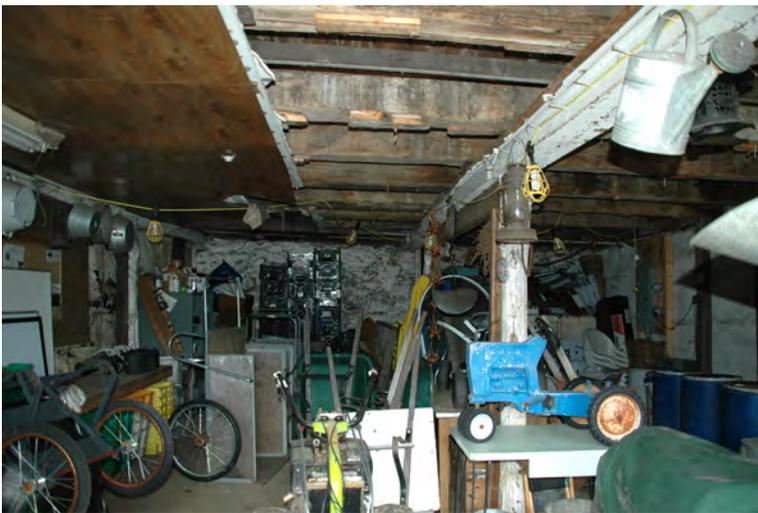
Figure 8 (bottom left): the lower level of the barn is a very utilitarian storage space, with various materials used

- Some floor joists exhibit damage. Investigate their structural integrity and supplement as required.
- Some floor boards at the main floor have water damage visible from below. In some locations there are holes where the boards are fully deteriorated. Repair or replace as necessary.
